Product:Washing	Noise in FHP-motor Part No. 8063734	Group:21	
Date: 2002-08-20		Number: 177	
Reference:N-Å Carlsson		ÄO:	Page: 1(1)

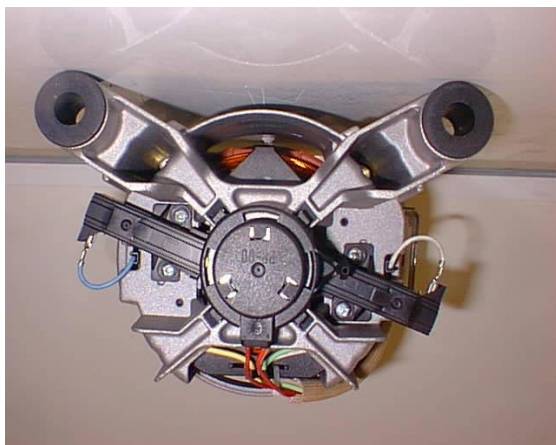
The noise occurs when the carbon brush (now made of a harder material) makes contact with the commutator at the wrong angle

1. Slacken the 2 retaining screws for each brush holder; see Fig. 1.
2. Rotate the brush holder slightly (ca. 1 mm) so that its tip is more in alignment with the commutator. The brush will now adopt a different angle to the commutator and will have a different contact surface; see Fig. 2.
